Pentagon Renovation and Terrorist Destruction Highlight Lessons Learned

By: Rachel Decker

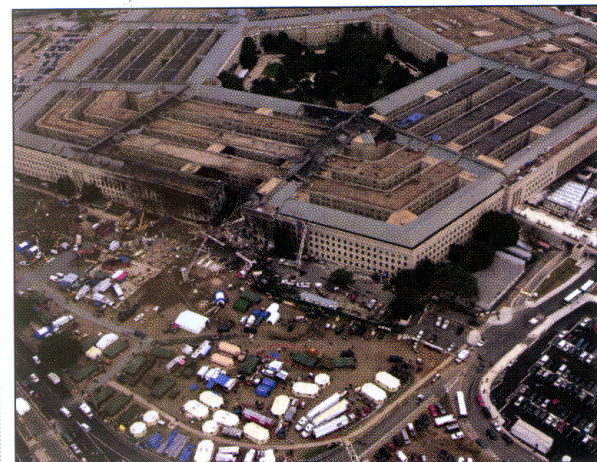
On September 11, 2001, a Boeing 757 struck the Pentagon's Wedge 1 on an angle and penetrated into an interior office ring in Wedge 2. Wedge 1 was just five days from completion, but the plane impacted areas that were only partially occupied.

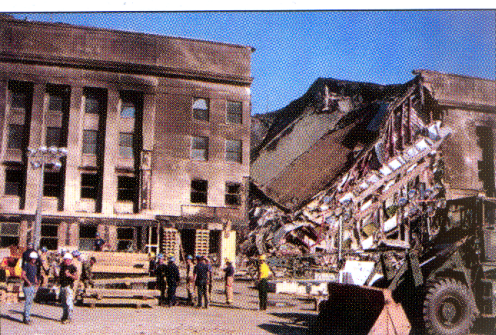
The old windows in Wedge 2 were shattered by the impact. Blast resistant windows in Wedge 1 were still in place directly above where the plane entered the Pentagon.

Despite the huge impact of the plane on September 11 and the resulting fireball that erupted as the plane's debris exited the C-ring, the blast resistant windows on the third and fourth floors, directly adjacent to the area which eventually

collapsed, remained intact. Several old windows in the not-yet-renovated Wedge 2 blew out. Lives were saved because of the steel reinforcement that surrounds the windows.

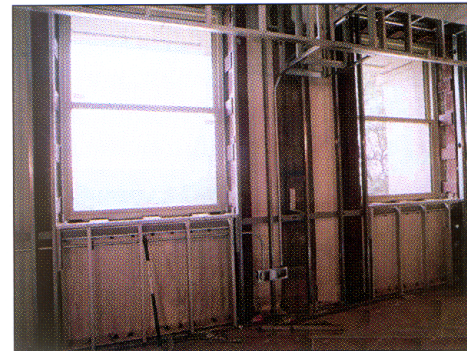
Exposed blast-resistant window

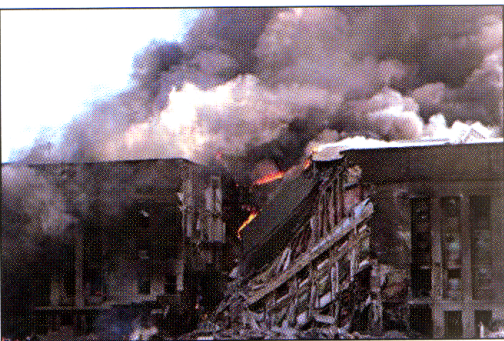
In Wedge 1, water from the sprinkler system squelched the flames that were not directly fed by jet fuel and contained the fire. However, without sprinklers, Wedge 2 had significant fire and smoke damage. Extensive water damage resulted from the thousands of gallons of water dumped into the impacted area. In all, approximately two million square feet of office space was affected.

Flames rage through the Pentagon September 11, 2001.

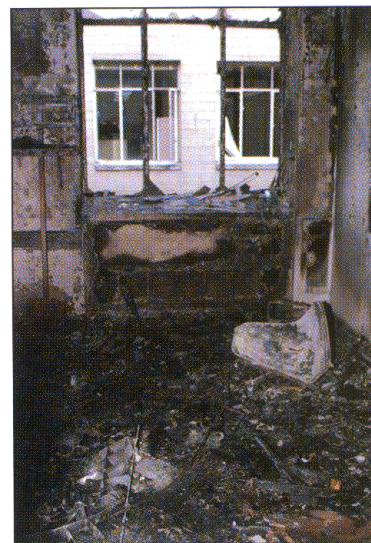
Damage inside an E-Ring office that lacked blast-resistant windows and steel reinforcement was much greater.
